Final Report

Program to Study the Oxidation of Carbon-Carbon Composites and Coatings on these Materials

by
J. Cullinan, J. Schaeffer, E. A. Gulbransen
G. H. Meier and F. S. Pettit

Materials Science and Engineering Department University of Pittsburgh Pittsburgh, PA 15261

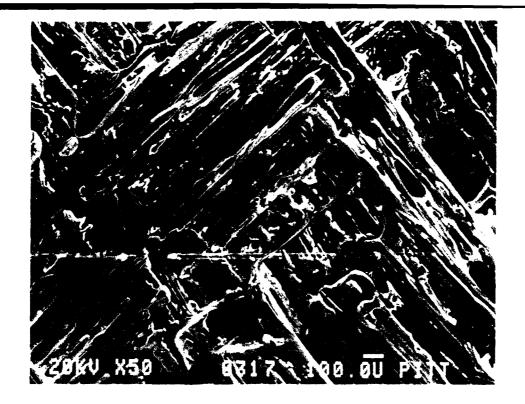
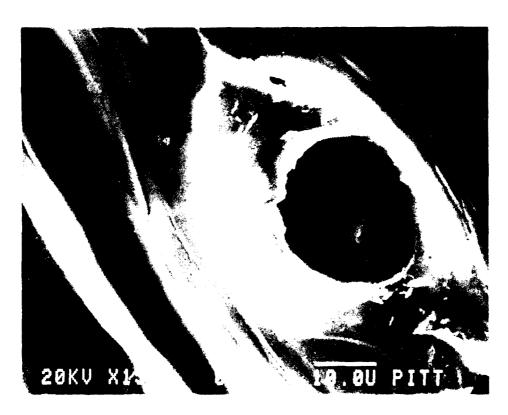
Figure 37. Boron oxide coats fiber regions of CC136E after isothermal oxidation at  $1100^{\circ}\text{C}$  in  $O_2$  flowing at 100 cc/min. The bottom shows cracking of the  $B_2O_3$  after cool down to room temperature.

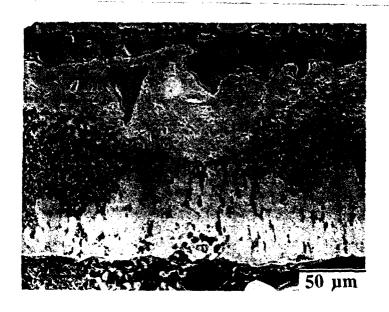
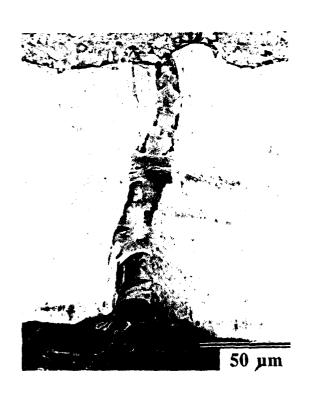
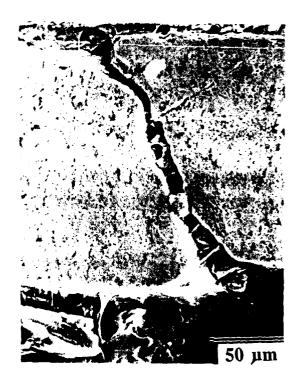
Figure 68. Cross sections of HP24 after isothermal oxidation at  $1200^{\circ}\text{C}$ . The top micrograph shows B<sub>4</sub>C stringers in the coating. The bottom micrographs show bubbling in the reaction products in cracks.

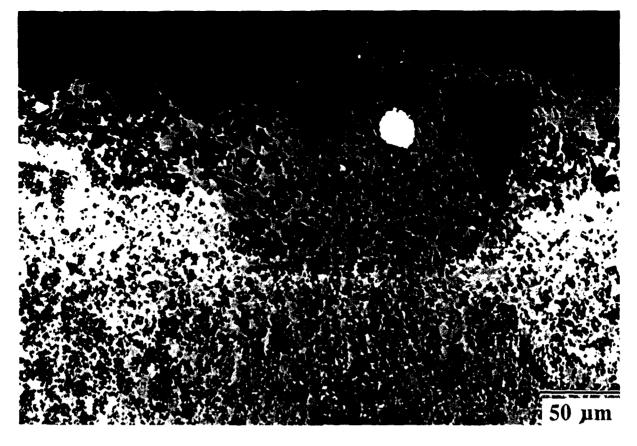
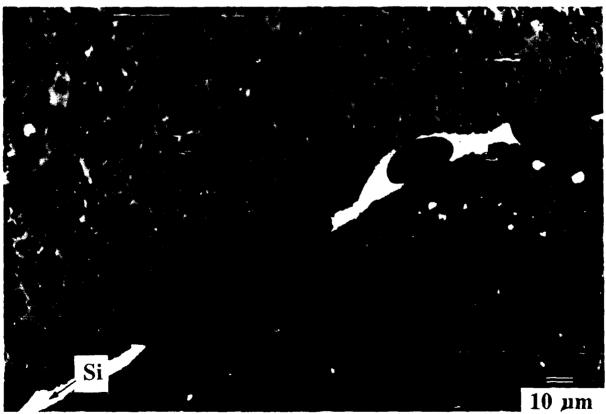
Figure 70. Optical micrographs show HP24 after oxidation in oxygen at  $1100^{\circ}\text{C}$  for 20 hours. Preferential attack of the bright free Si is observed in each micrograph. Dark particles are  $B_4\text{C}$ .

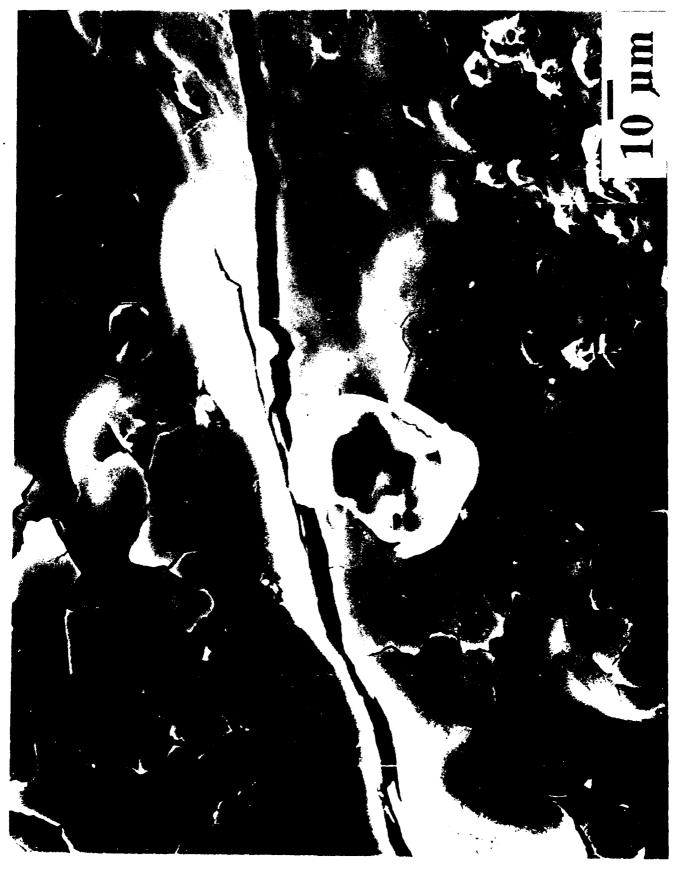
Figure 77. Surface micrograph of the No Glaze after isothermal oxidation in oxygen at  $1100^{\circ}\text{C}$ . The surface shows cracking and spalling of the silica scale.

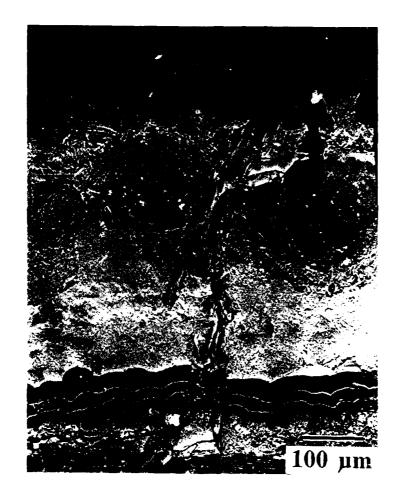
Figure 86. Micrographs of the glaze sample after 100 cycles in oxygen at 1125°C. The top micrograph shows a sealed crack. The bottom micrograph shows a cross section of the penetrated coating.

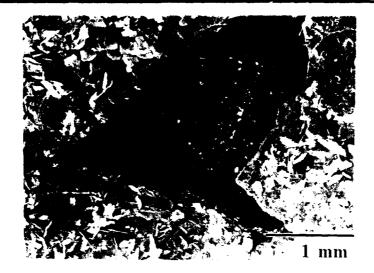
Figure 88. Surface micrographs of the glaze sample after cyclic oxidation at  $900^{\circ}$ C. The top shows a large failure site. Some boron oxide surrounds the failure site. The other micrographs show cracking and spalling on the surface.
